REVISED ANADROMOUS STREAM CATALOG OF SOUTHEASTERN ALASKA

District 106

Northeast Coast of Prince of Wales Island

Subdistricts 106-30 and 106-10

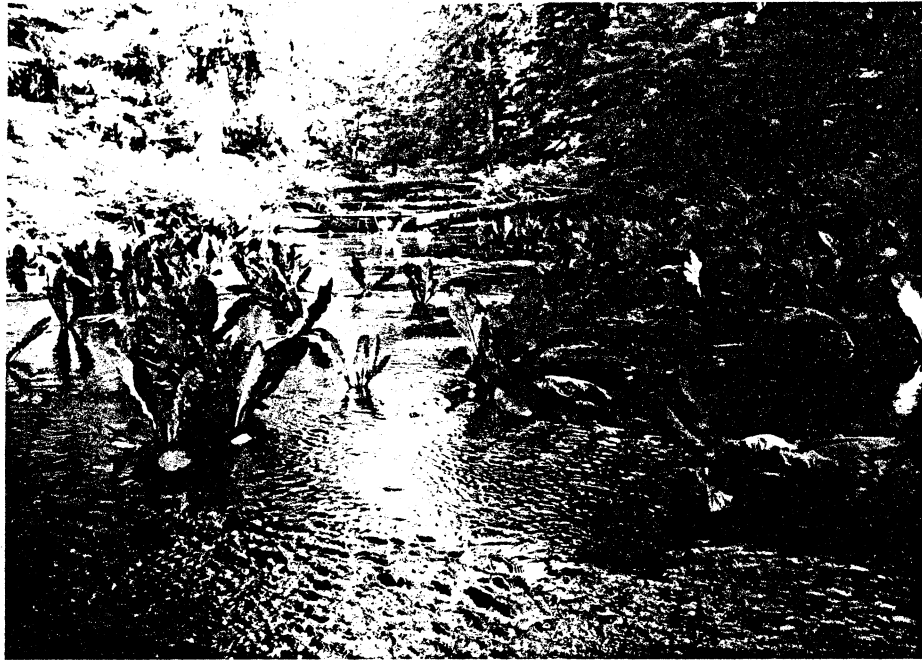
3. Forbs growing in shallow, wide channel of Section 1.

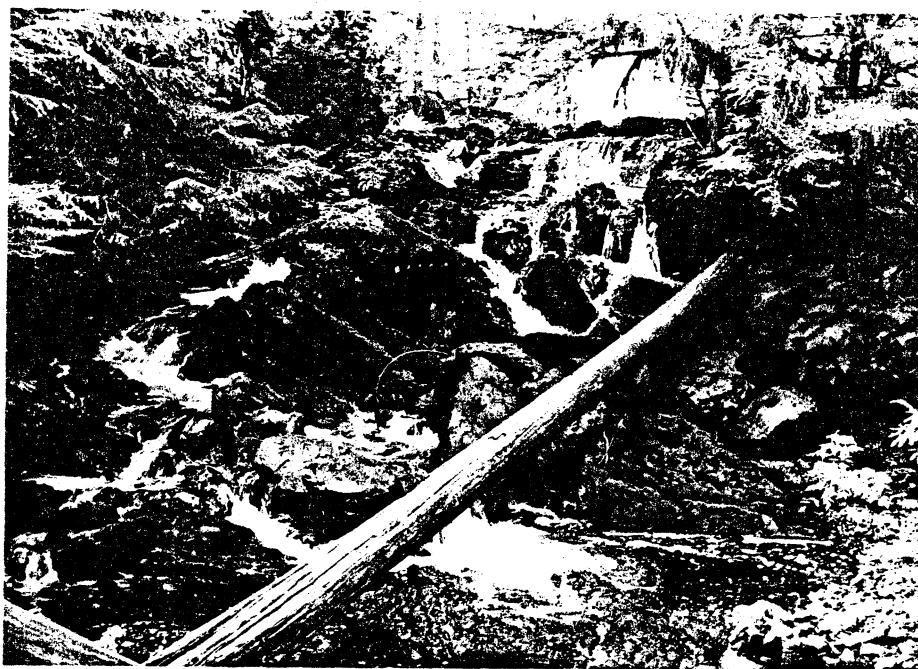
5. A 7 m cascade in Section 5 is a potential barrier to pink and chum salmon. Coho fry were common above the cascade.

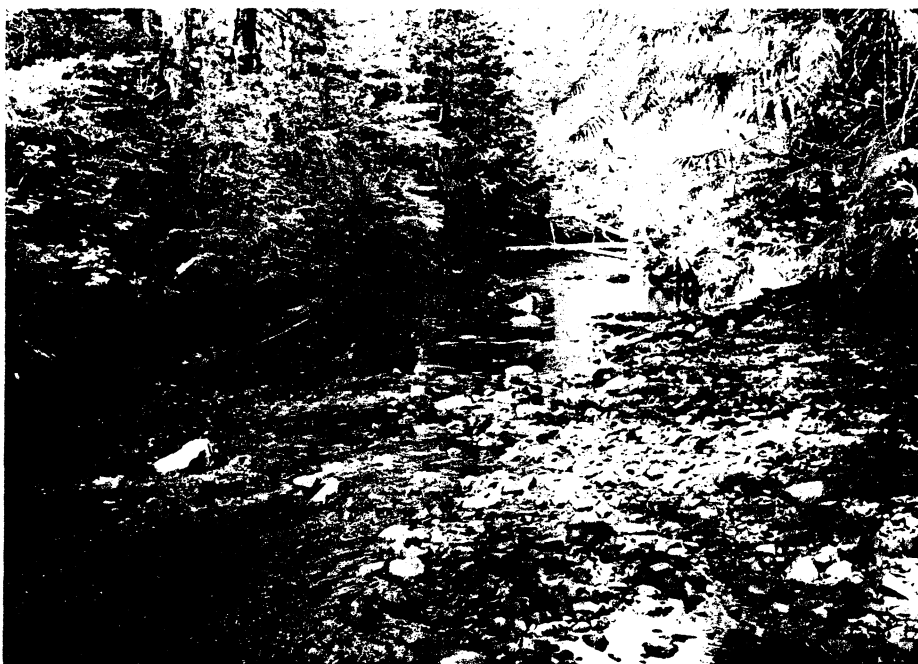
6. Section 6: Low gradient and good ASA just above the cascade.

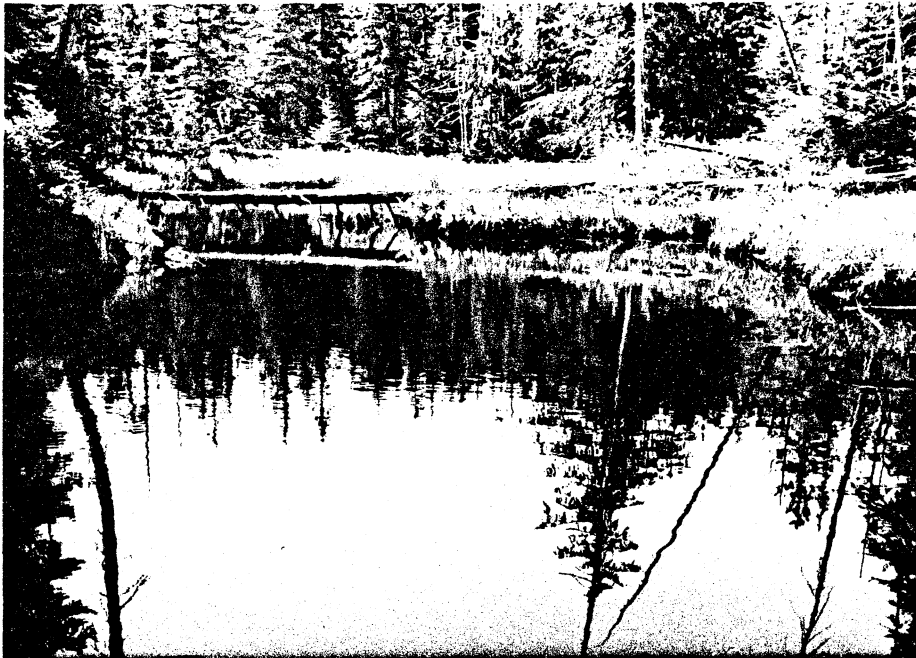
7. The stream becomes sinuous and slough-like in Section 9.

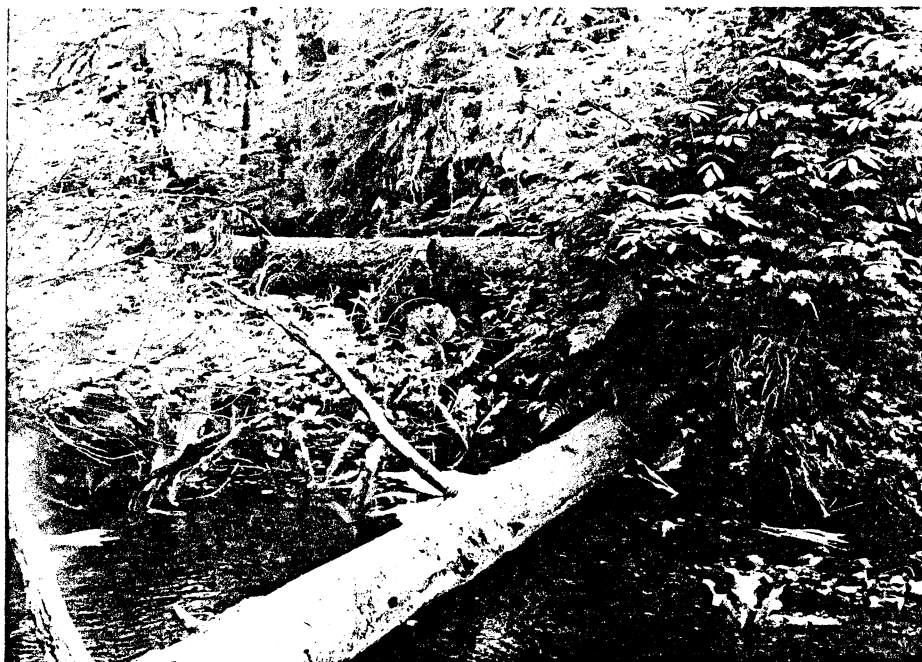
9. The mouth of Survey Area "B".

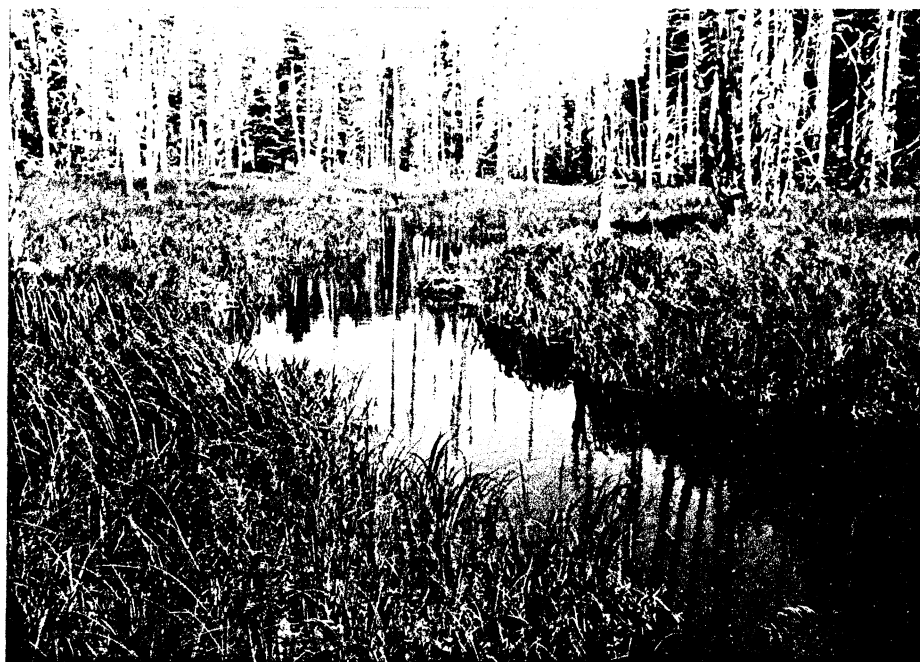
10. Survey Area "B": Section 4 is a channelized beaver system which travels through a wide, grassy floodplain, similar to Section 2 & 3.

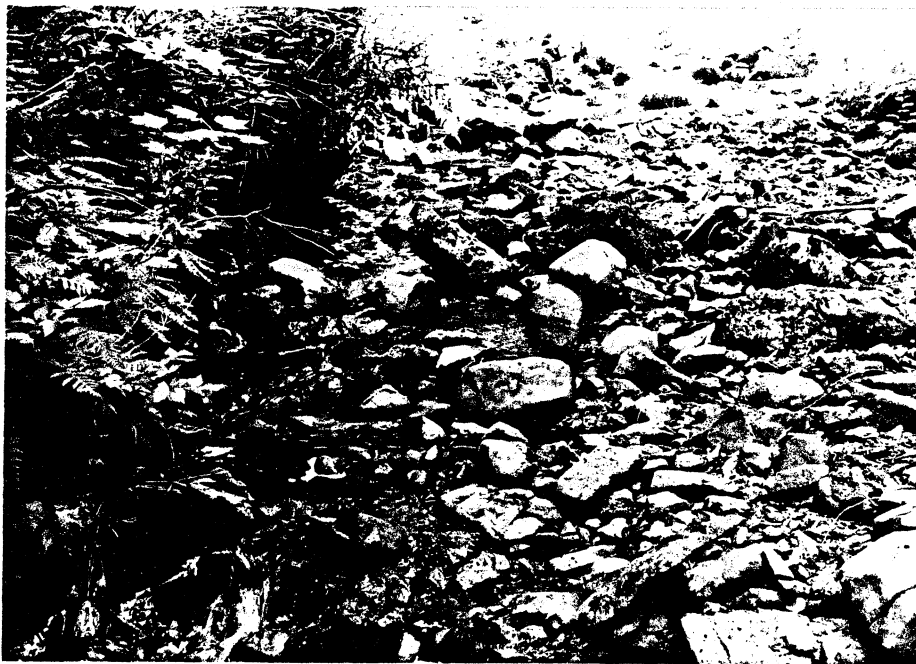
12. Survey Area "B": An abrupt gradient increase occurs as the stream enters a V-notch in Section 6.

- Section 4: Abrupt gradient increase. Stream enters a V-notch. Substrate consists mostly of large cobble and boulder. A 2 m falls at the end of the section may be a barrier to pink and chum salmon.
- Section 5: Gradient increases. Bedrock and boulders are the dominant substrate. A 7 m cascade almost certainly is a barrier to pink and chum salmon. Coho fry are found above the falls.
- Section 6: Low gradient. Substrate consists of gravel and small cobble interspersed by bedrock patches.
- Section 7: Substrate shift to larger size.

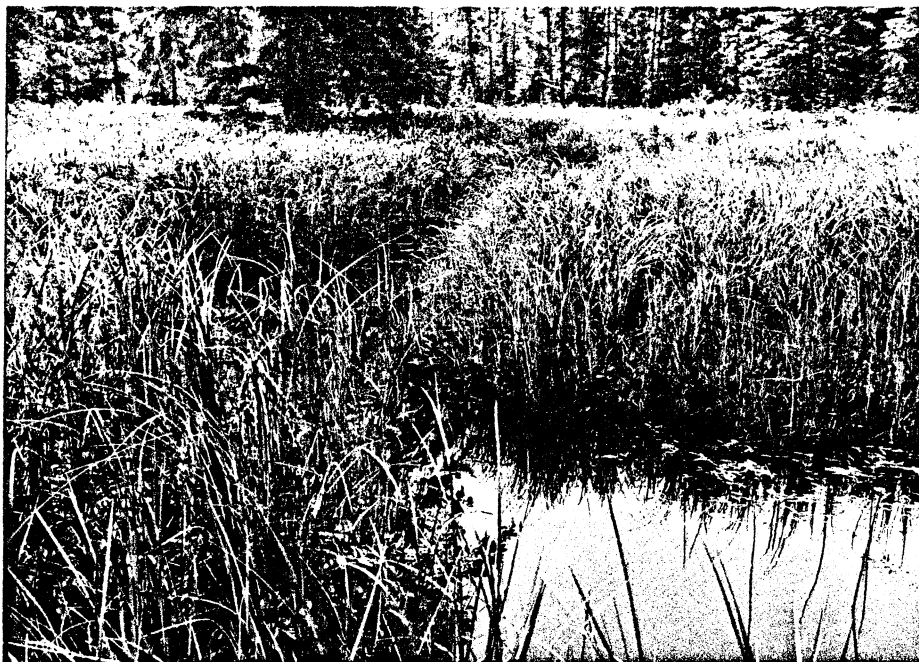
13. The mouth of Survey Area "C" taken from Lake II.

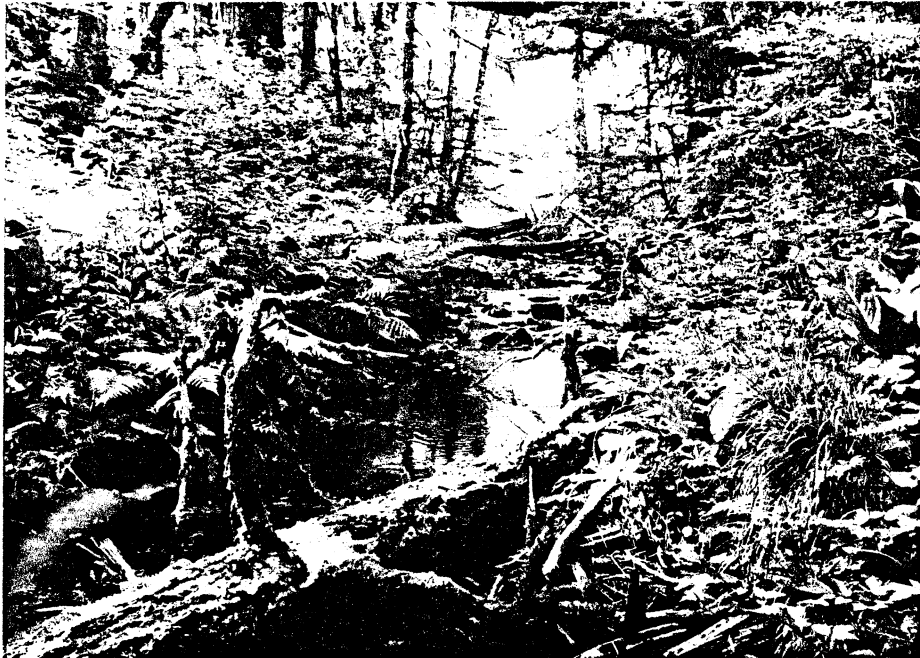
15. Survey Area "C": The stream enters the forest at Section 3.

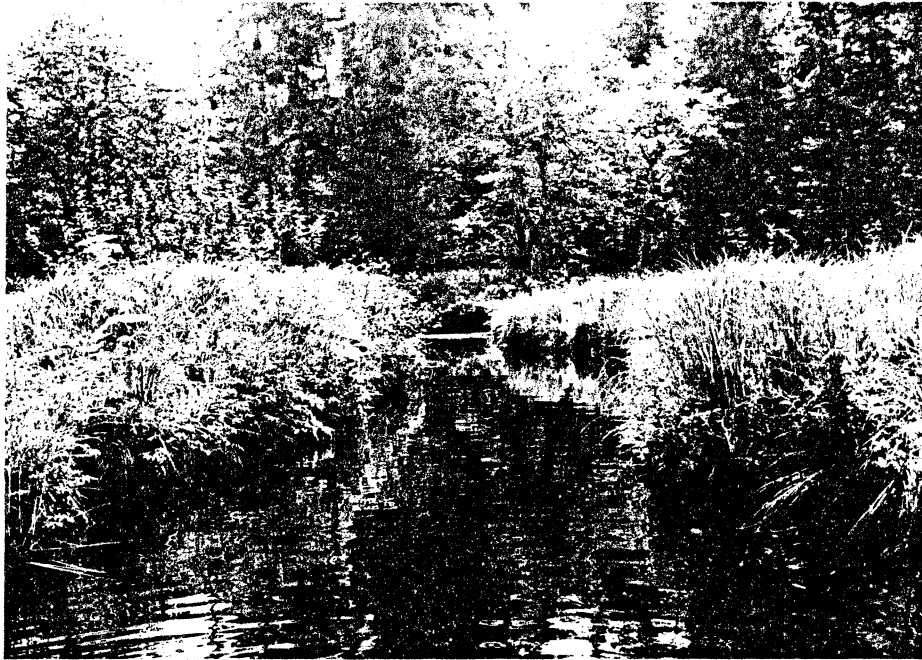
17. The mouth of Survey Area "D" taken from Lake II.

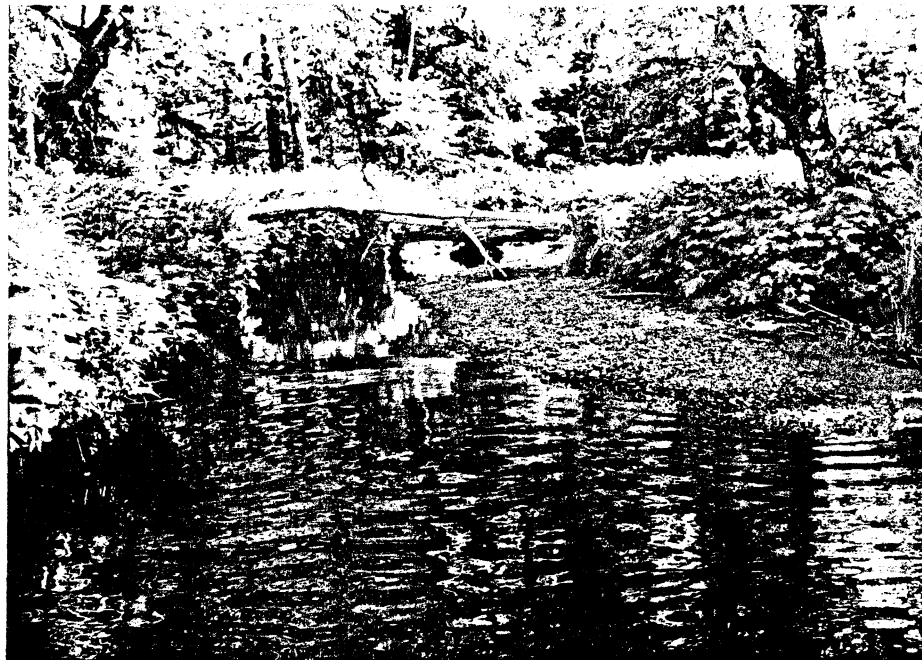
18. Survey Area "D". Large pools in Section 1 provide excellent rearing habitat.

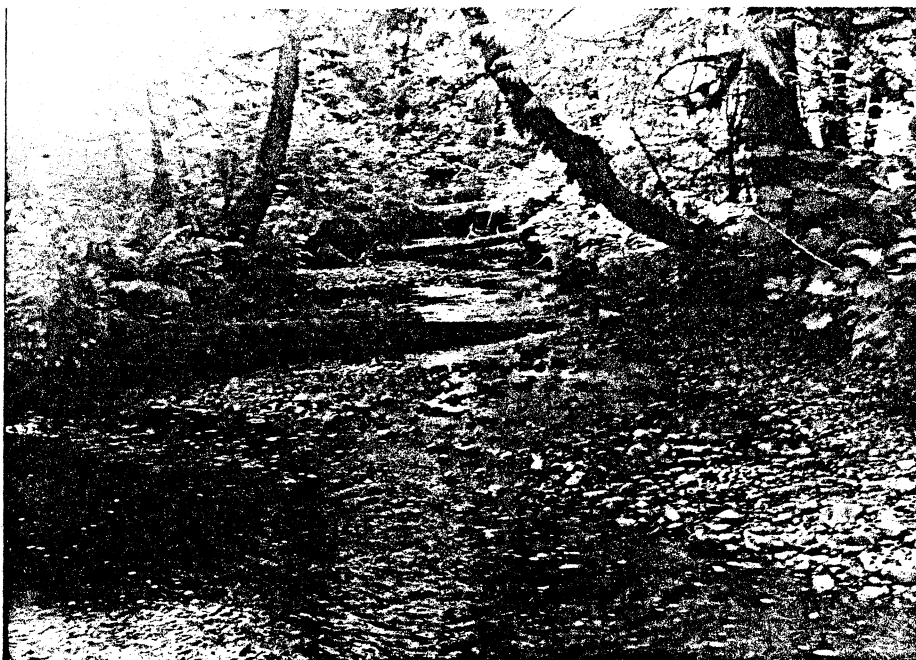
19. The mouth of Survey Area "D-1".

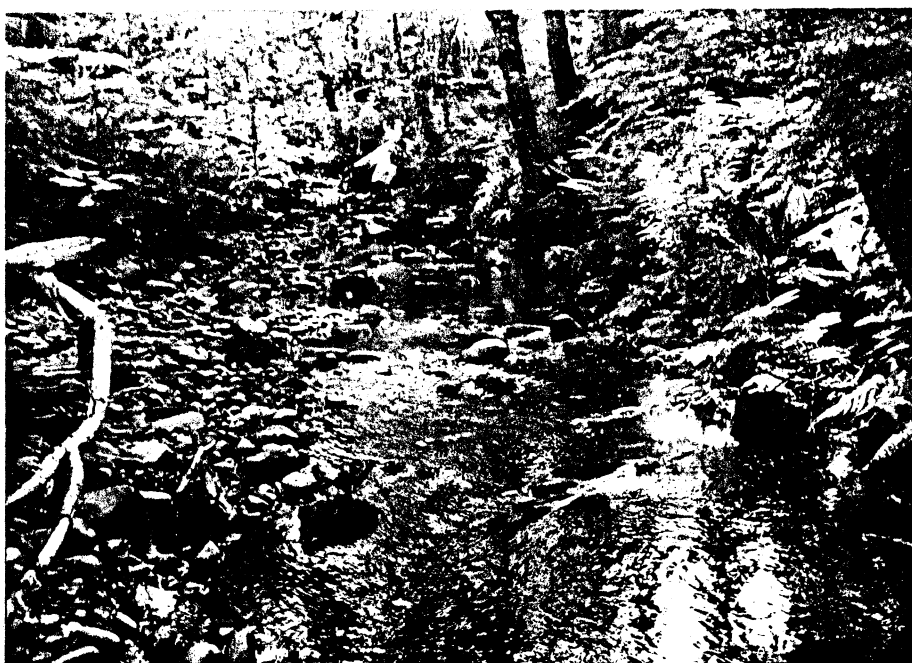
20. Survey Area "D-1": Large cobble substrate in Section 2.

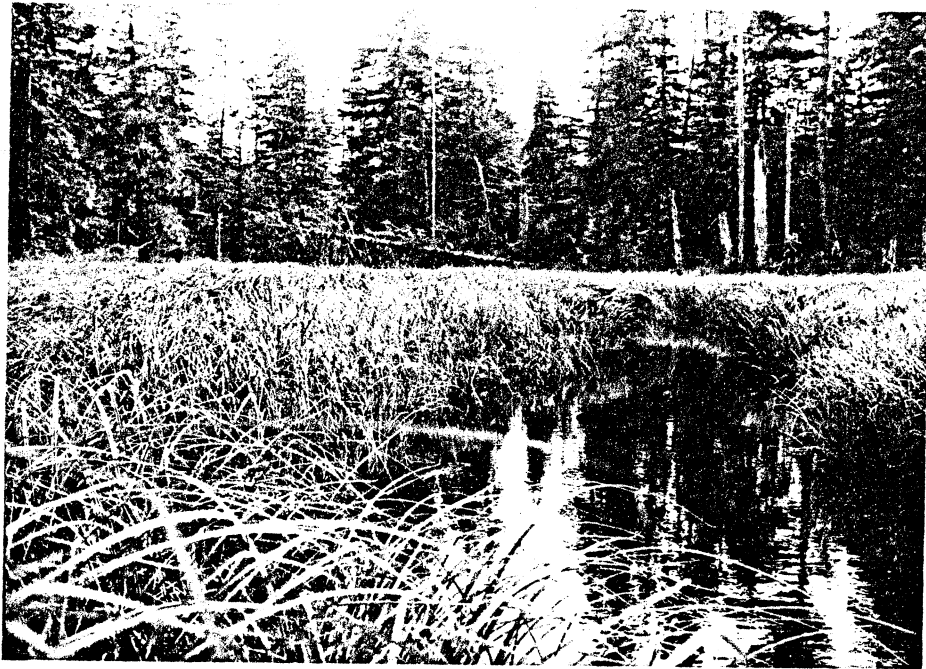
21. The mouth of Survey Area "D-2" taken from Lake III.

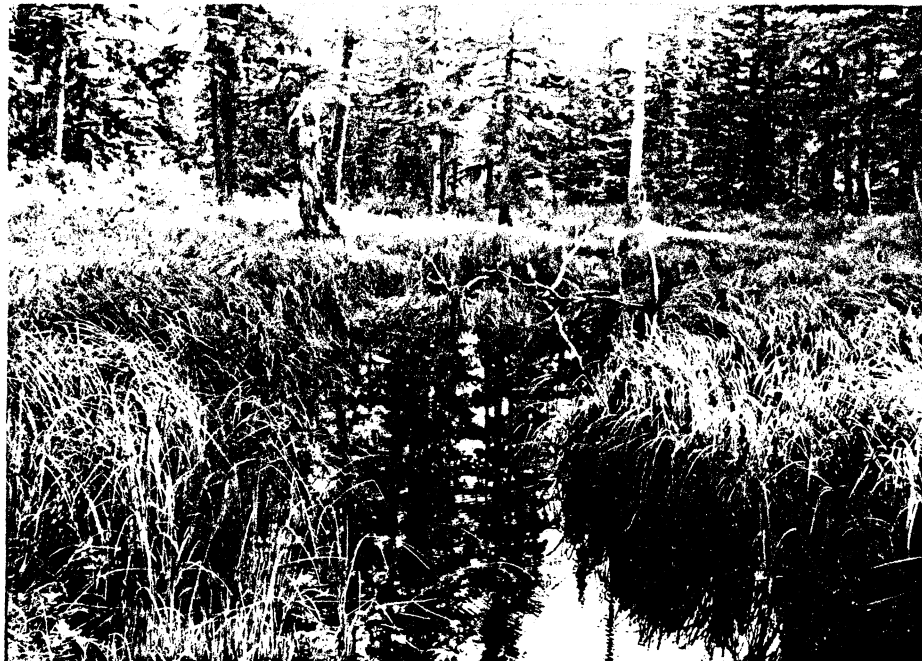
22. Survey Area "D-2": Section 1 is sinuous, traveling through a wide, grassy floodplain.

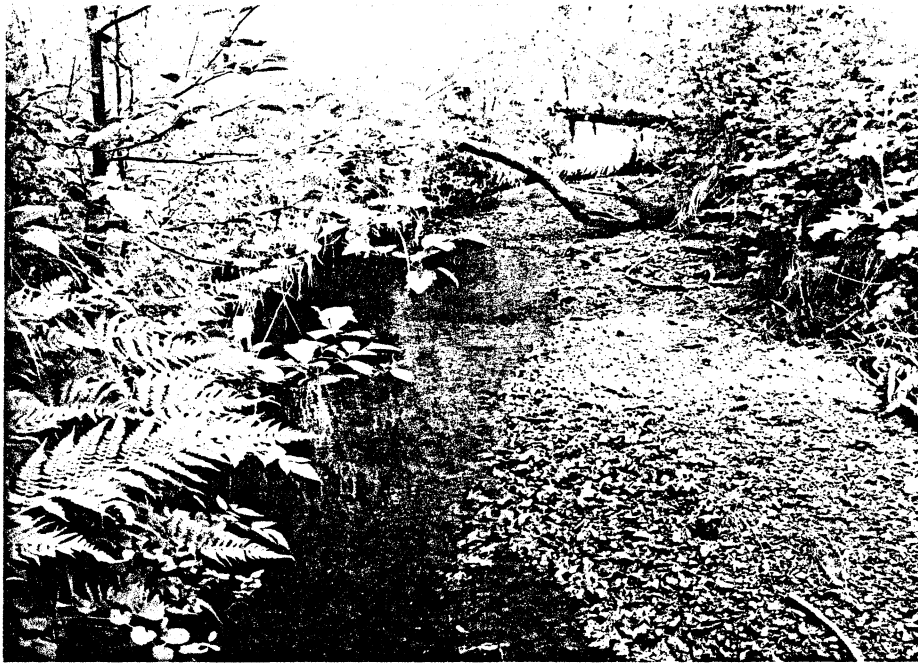
23. Survey Area "D-2": Section 2 contains intermittent regions of gradient providing some ASA.

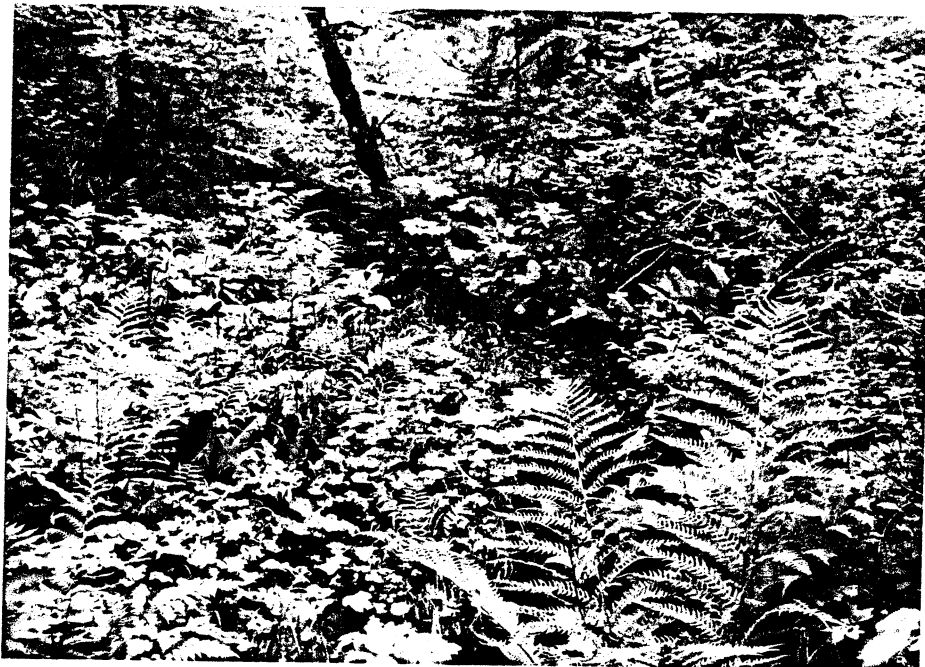
24. Survey Area "D-2": Section 5 has increased gradient through the forest. Fish habitat diminishes.

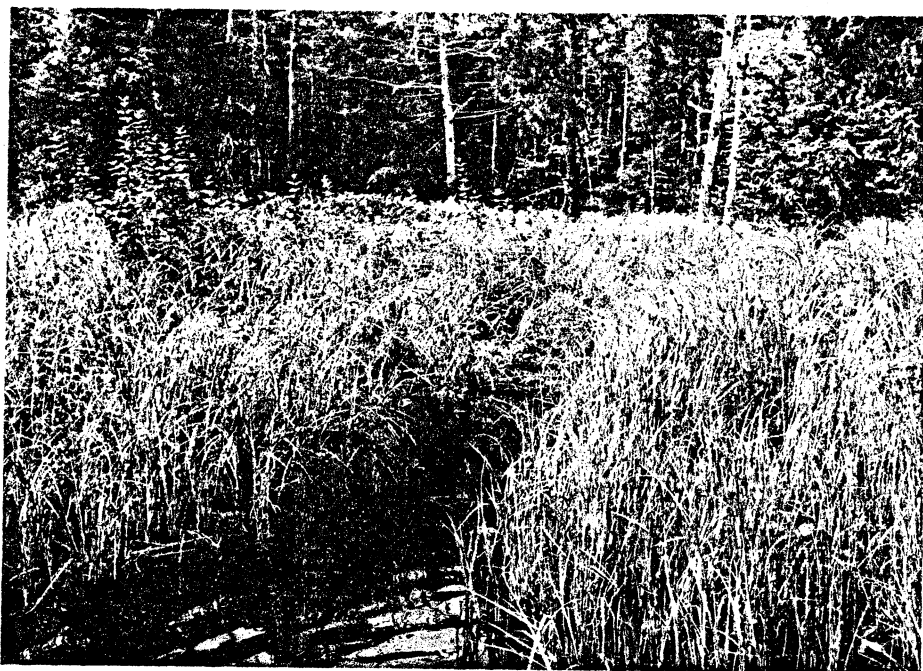
25. The mouth of Survey Area "E" taken from Lake II.

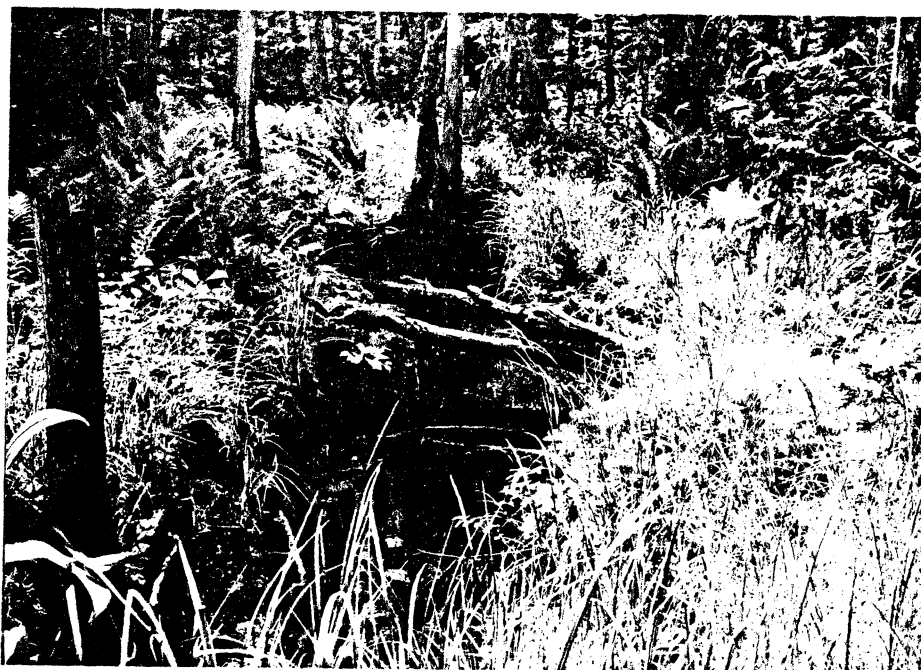
26. Survey Area "E". Sharply undercut banks and a good pool/riffle ratio provide good rearing habitat in Section 1.

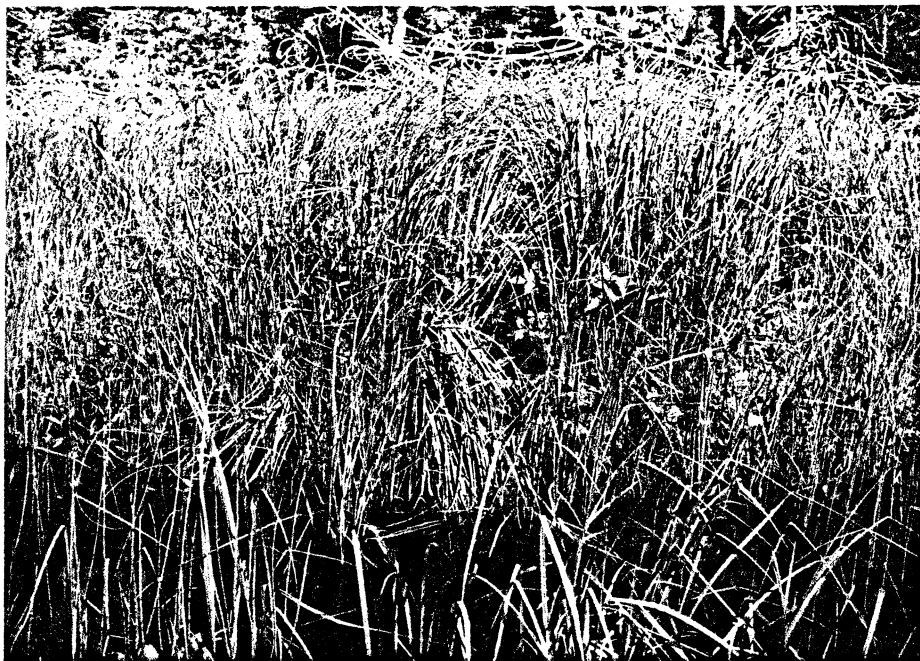
27. Survey Area "F": The mouth of the survey area taken from Lake II.

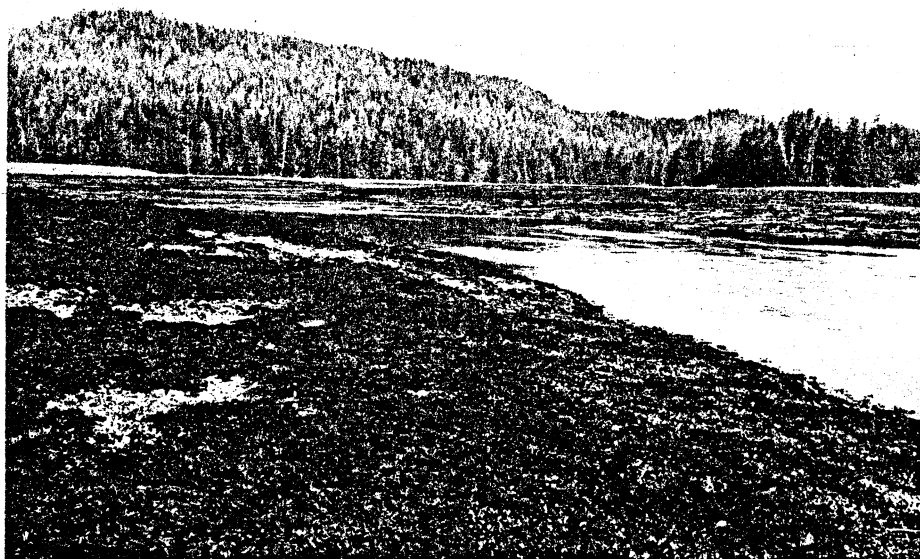
1. Lower ITZ at low tide.

The lower ITZ is primarily a large mud flat with heavy fines in the cobble substrate of the stream channel. Large populations of mussels and clams were observed here, as well as considerable amounts of aquatic vegetation (rockweed, Ulva spp., etc).

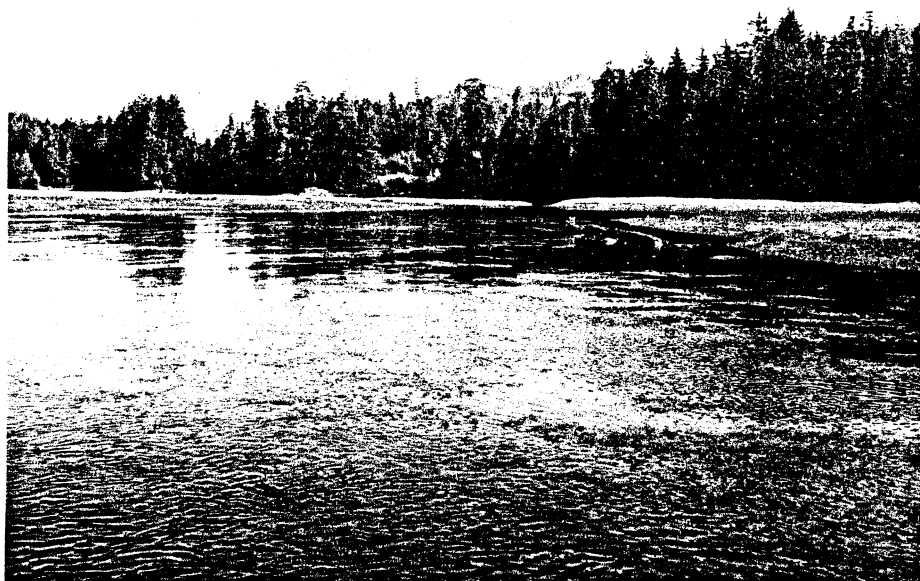
2. Middle ITZ in grass meadow with heavy concentration of fines. Adjacent road visible (middle right of photo).

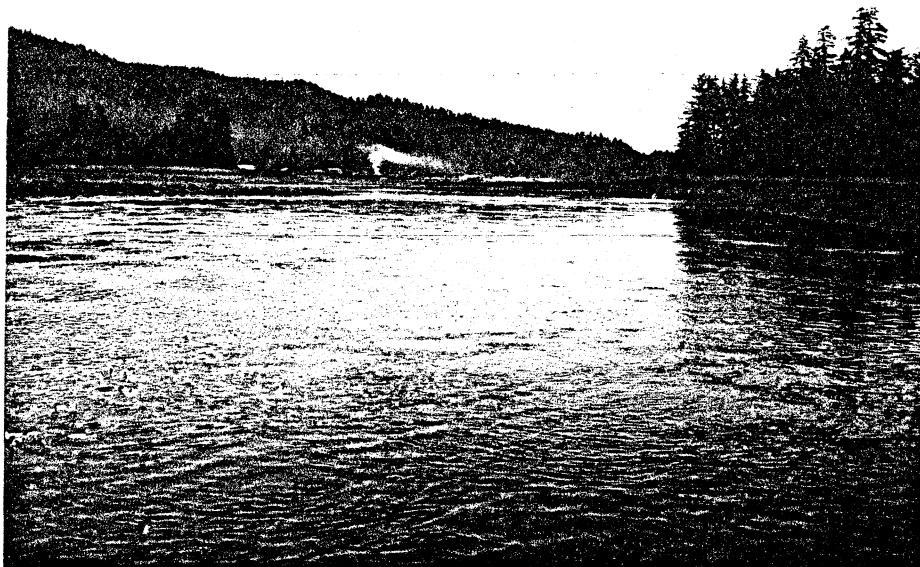
3. Downstream view of ITZ with Whale Pass logging camp in background.

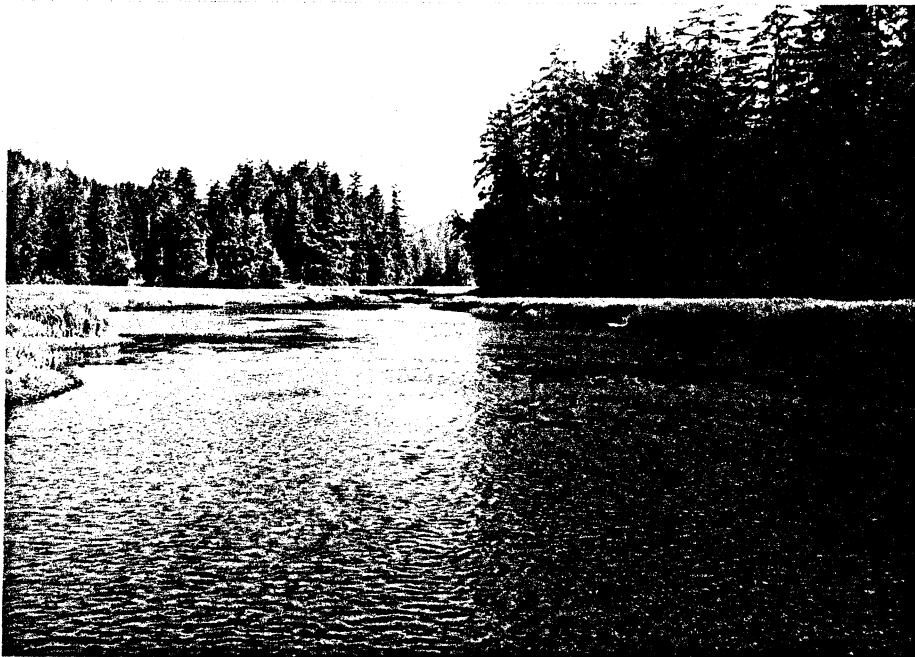
4. Upper ITZ with good spawning riffle; log stringer bridge crossing.

The upper ITZ has excellent gravel riffles which seemed significant enough to warrant sectional survey (Reach I). This 400 meter stretch is excellent pink and chum spawning area with shallow riffle over loose gravel. Large amounts of coho fry were observed in this area. The bridge crossing is a bi-span log stringer bridge with a footing on an island. The aborted first bridge crossing is located at Section 2I: 65m. The old ADF&G weir site is located at Section 4I: 100m. After this point the stream channel narrows and the ITZ ends.

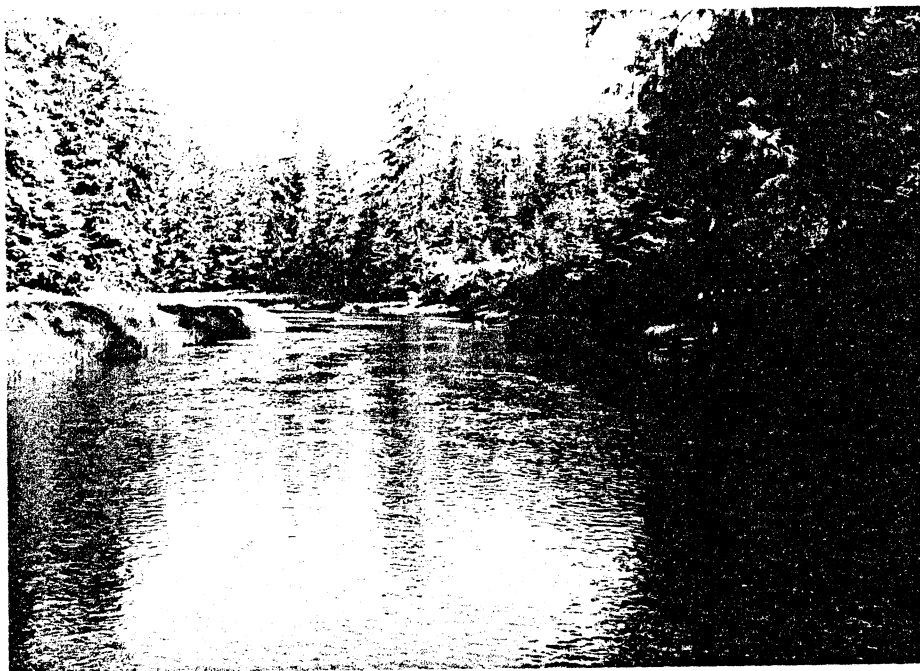
5. Excellent spawning riffle in ITZ above bridge crossing.

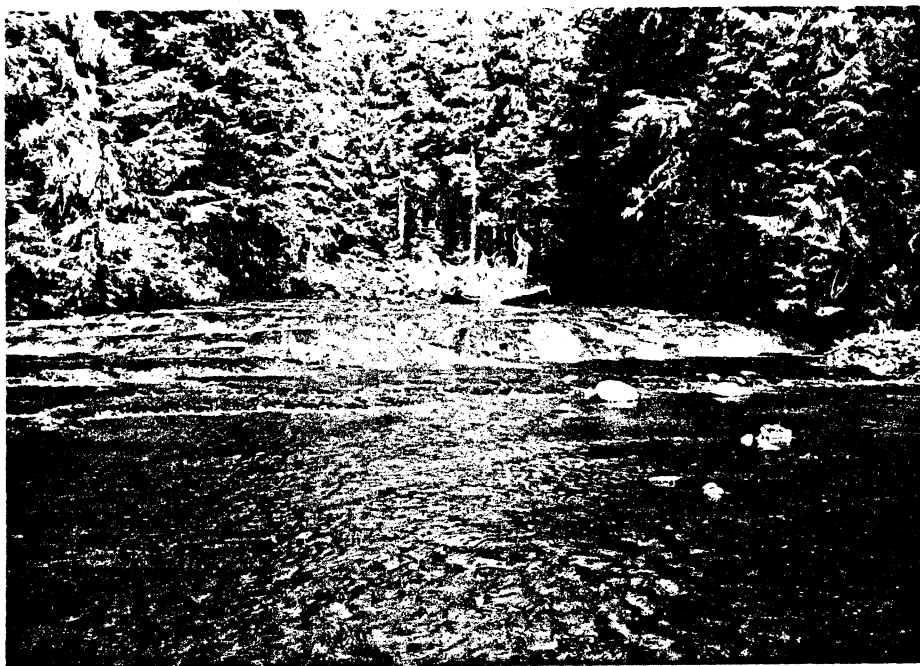
6. Reach 2: Section 3: 0m; 2 meter cascade over bedrock at 10% slope.

As the stream channel width narrows, the velocity and gradient noticeably increase. The substrate changes to bedrock/boulder/cobble with no ASA. A 2 meter cascade over bedrock occurs 200 meters from the mouth of the stream, but does not constitute a barrier. Blowdown logs have apparently been removed from the channel in stream cleanup operations. Above the cascade, the USGS gaging station and cable car are located. Few coho and trout fry were observed in this Reach.

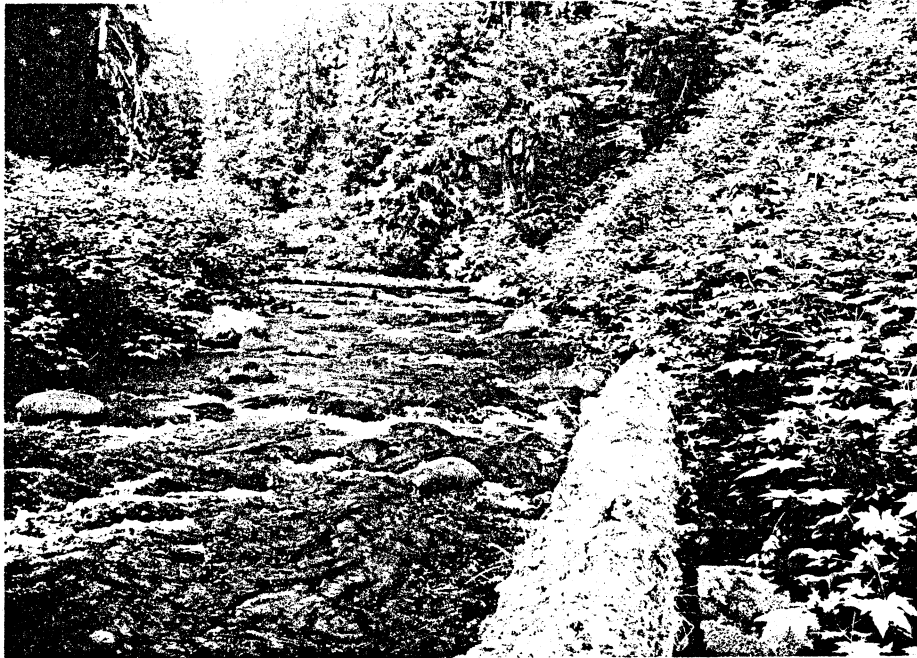
11. Reach 4: Section 16: 0m; Channelized, high velocity flow over boulder/cobble.

This reach is characterized by high velocity flow over boulder/cobble substrate between steep banks with little fish habitat. Small populations of trout fry were observed and very few coho fry. Areas of blowdown with associated soil slumps are scattered through the Reach.

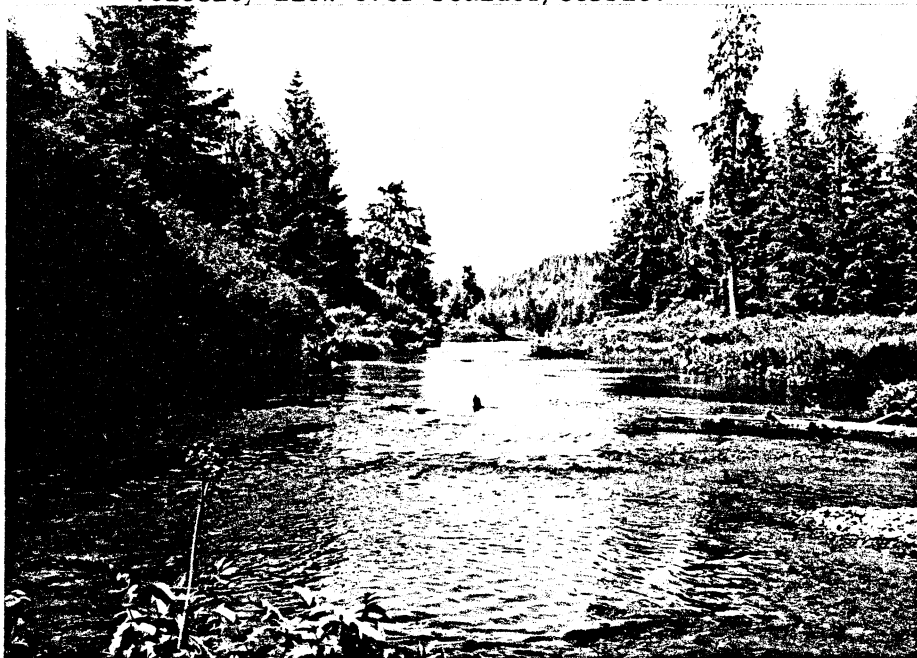
12. Reach 5: Section 19: 0m; Wide shallow flow over gravel wholly within unit with no canopy cover. Water temperature; 10°C.

At Section 19: 0m, the stream characteristics change sharply. The stream channel becomes wide and shallow as the gradient and velocity decrease. The substrate is predominantly gravel with little instream debris. The entire Reach is within an old unit, completely cut to the banks with no canopy of streamside cover whatsoever. A continuous sheet of "slime" covers the substrate. The water temperature jumps up to 20°C (68°F). Large concentrations of coho and trout fry were observed in this temperature sensitive area. Isolated soil slumps are located within the unit.

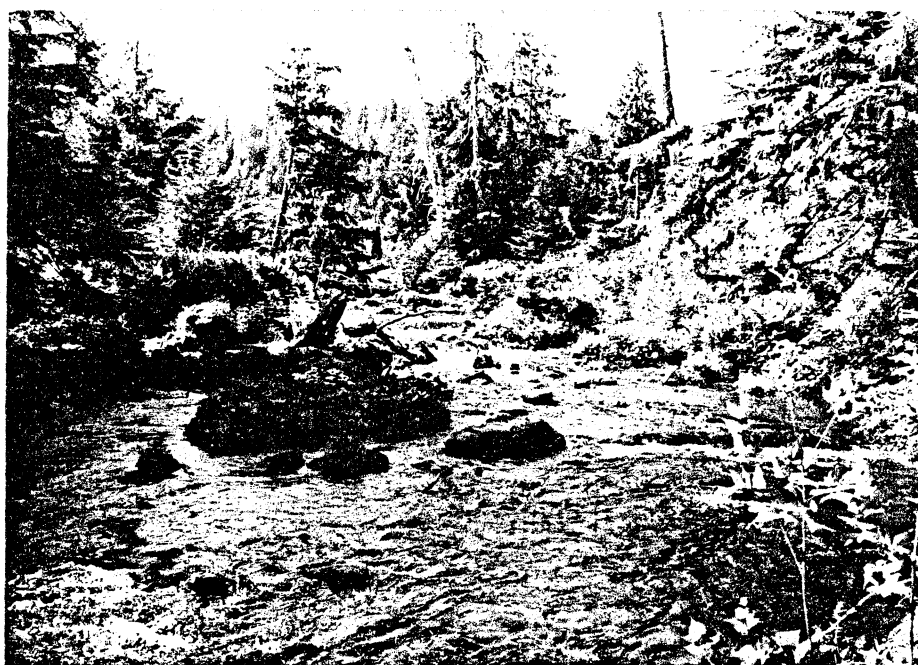
13. Reach 6: Section 26: 30m; Stream flow over boulder/cobble within unit.

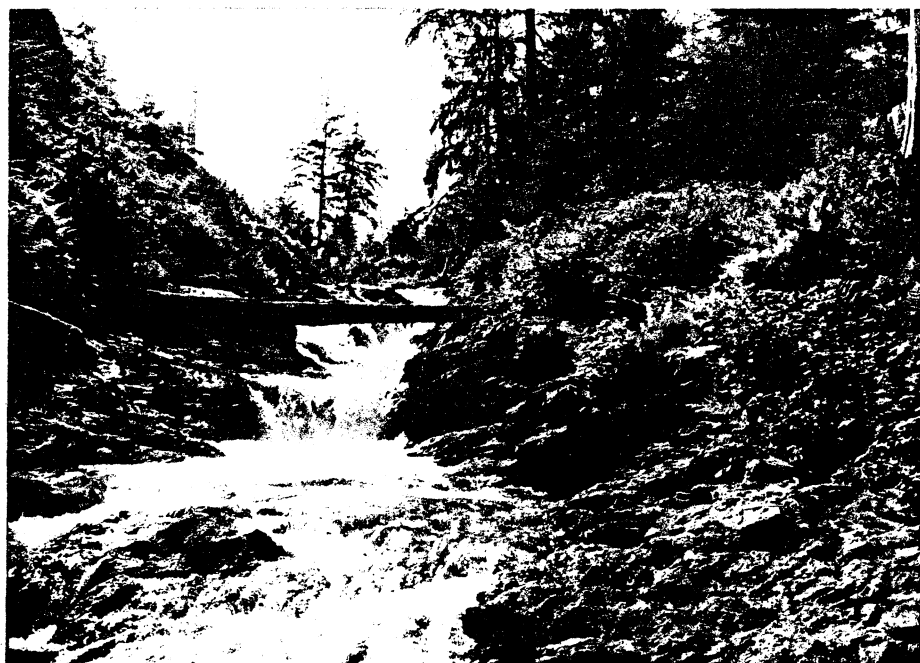
14. Reach 6: Section 31: 50m; Staircase succession of cascade/falls 30 meters in total height over bedrock.

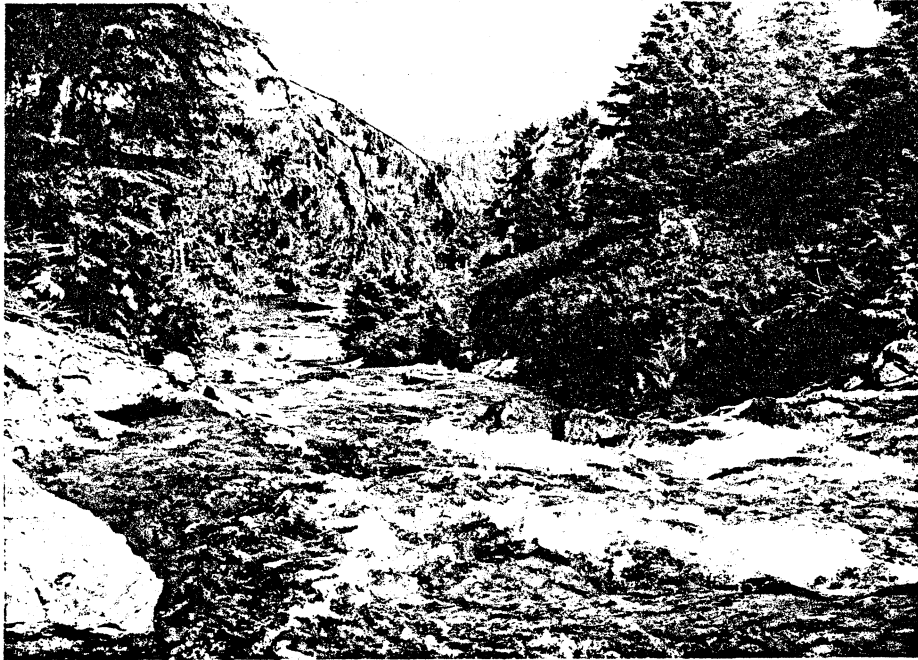
15. Downstream view from falls at Section 31: 50m;
with large drop evident. Units present on both
banks.

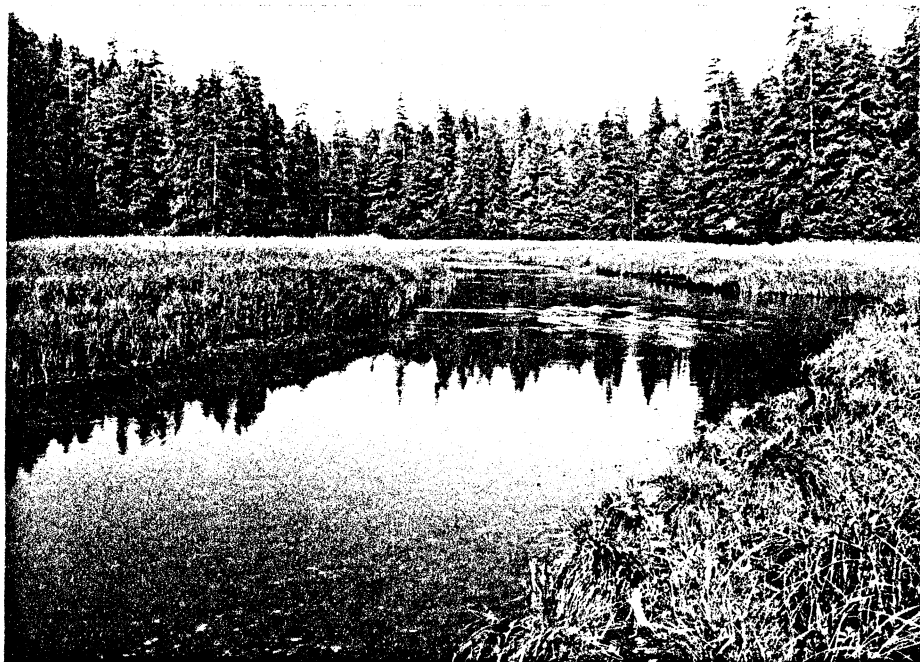
1. Upper ITZ forms an extensive, productive estuary. Channel enters timber left center.

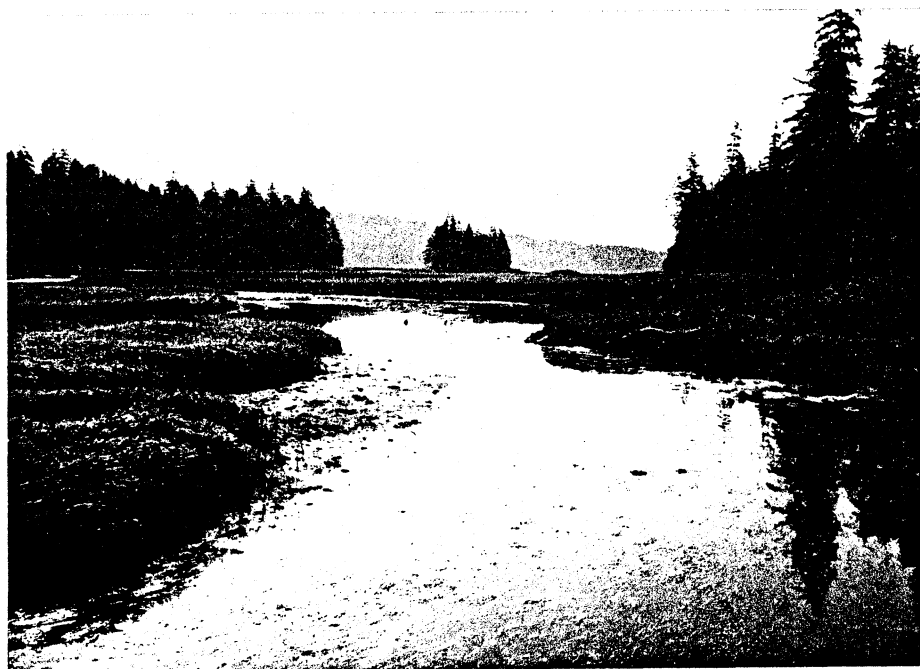
2. View of extensive estuary to Whale Pass. The ITZ provides excellent rearing habitat, however, abundant interstitial fines reduces ASA.

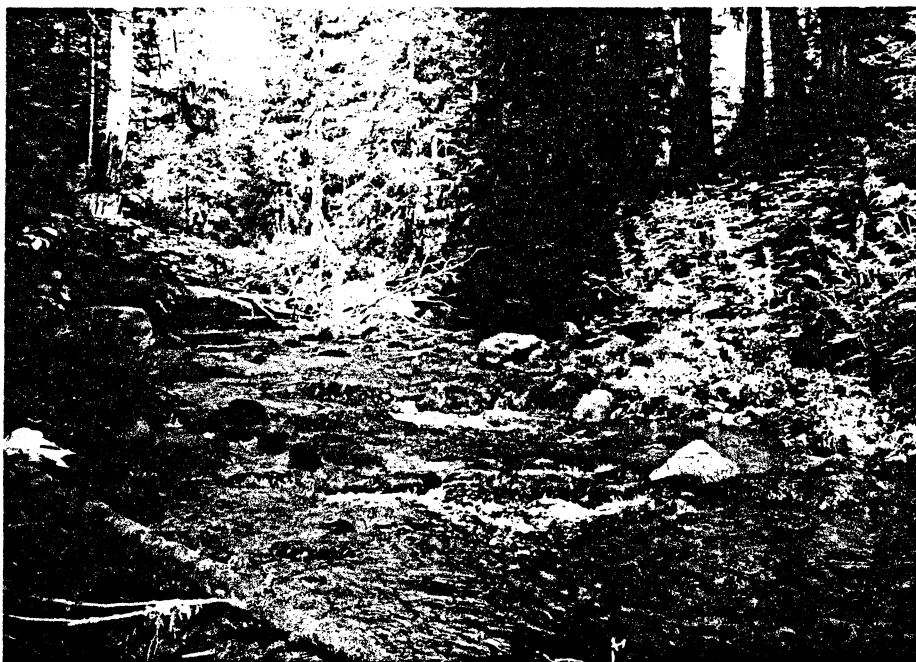
3. Section 1: The ITZ ends approximately 75 meters above a bridge crossing and the habitat type is predominantly boulder riffles.

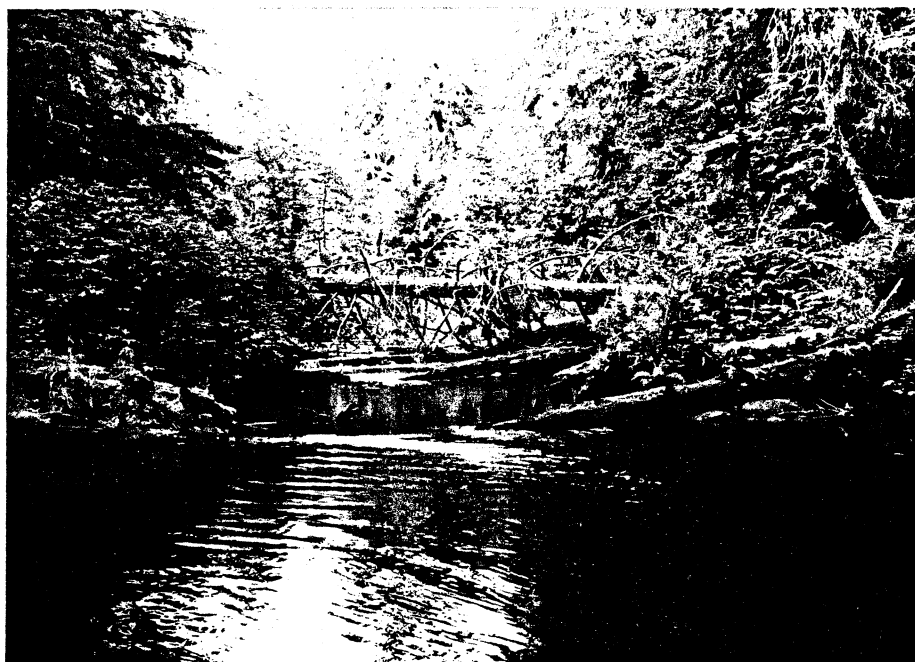
4. Section 3: Channel broadens and copious blowdown provides good rearing cover.
